# Manhole Inspection Summary

Manhole # S63I\_\_014MH

**Location** Address: **5700 Eastern Ave.**

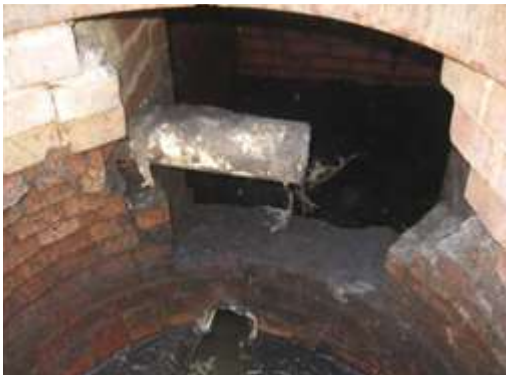
Defect 2

Comments **HOLE IN SIDE OF MANHOLE MAY BE AN OVERFLOW DEVICE. SITE SURCHARGES FREQUENTLY.**

Hole in barrel wall

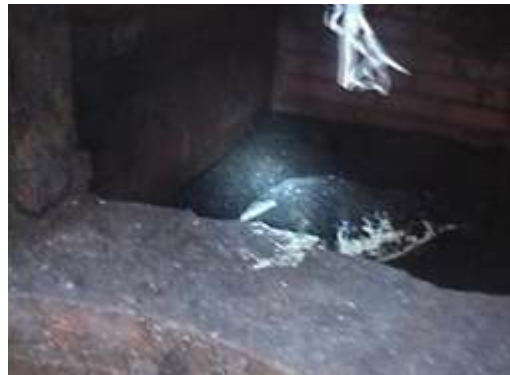
Defect 3

I6 visible through hole

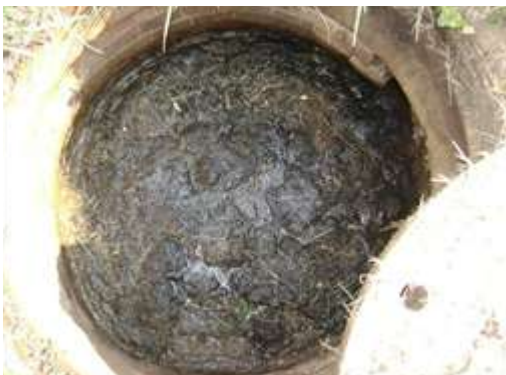
Defect 1

**Surcharge** ☒ **Evidence Of Surcharge** Depth: **12** (ft.) ☐ Active Surcharge Present

surcharged at first inspection attempt.

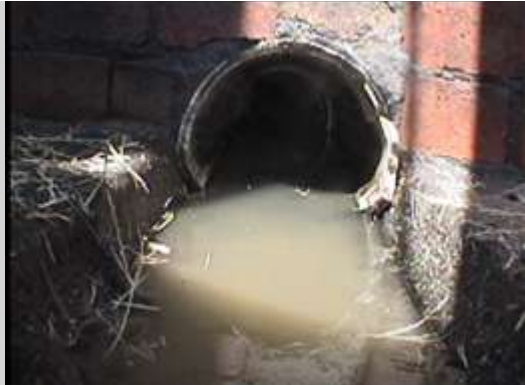
12 O'Clock Outflow

Pipe Height: 6 (in.) Rod and Bar (Angled)  
Pipe Material: **PVC** ☐ Pipe Lined  
Invert Depth: **4.25** (ft.) Flow Characteristics: **Slow**  
Deposits: ☐ None ☒ **Mud** ☐ Sludge ☒ **Debris** ☐ Grease  
Silt Depth: **2** (in.) Deposits Extent: **Medium**  
Infiltration: **None** Pipe Seal Cond: **Sound**

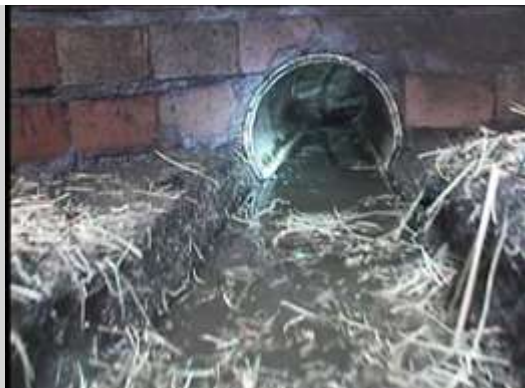
6 O'Clock Inflow

Pipe Height: 6 (in.) Rod and Bar (Angled)  
Pipe Material: **PVC** ☐ Pipe Lined  
Invert Depth: **4.17** (ft.) Flow Characteristics: **Slow**  
Deposits: ☐ None ☒ **Mud** ☐ Sludge ☒ **Debris** ☐ Grease  
Silt Depth: **2** (in.) Deposits Extent: **Medium**  
Infiltration: **None** Pipe Seal Cond: **Sound**
